Fired Heater Study Report

Vacuum Heater

HeaterSIM ref: H-13114

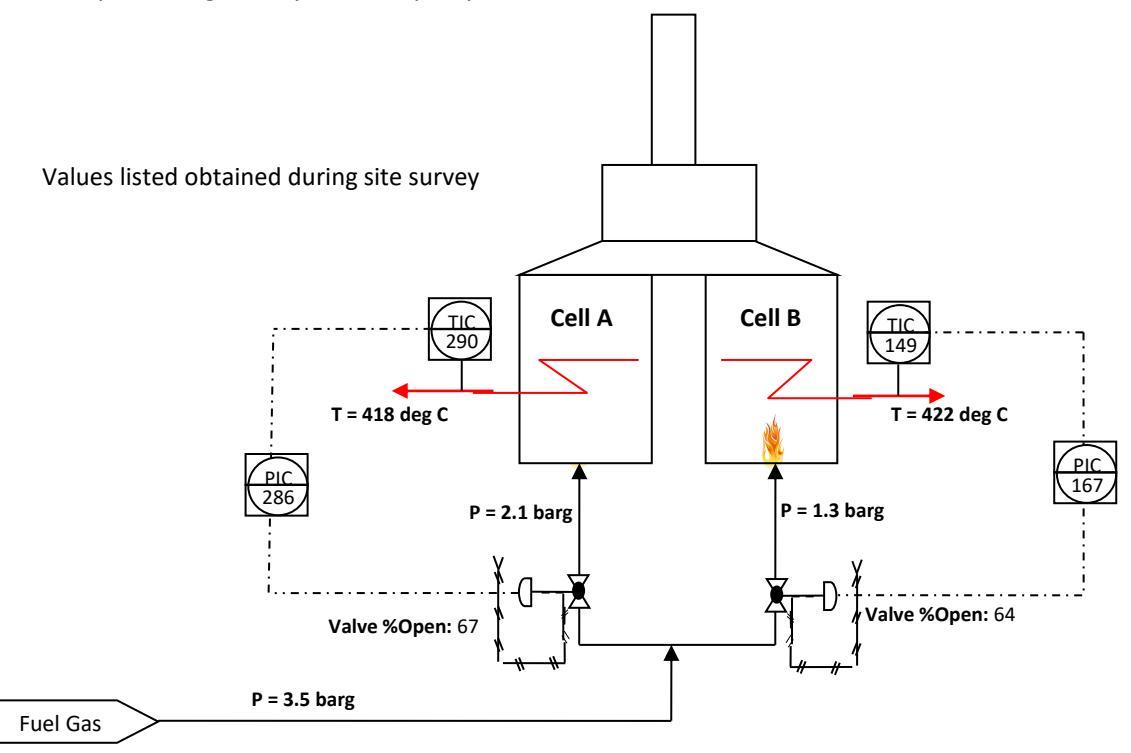
2.2. The fuel gas supplied to each radiant cell is modulated by a separate Pressure Control Valve (PCV) that is linked on a control loop with the process outlet temperature of the respective cell. Site measurements showed a discrepancy between the fuel gas pressures downstream of the valves, despite being at very similar open positions.

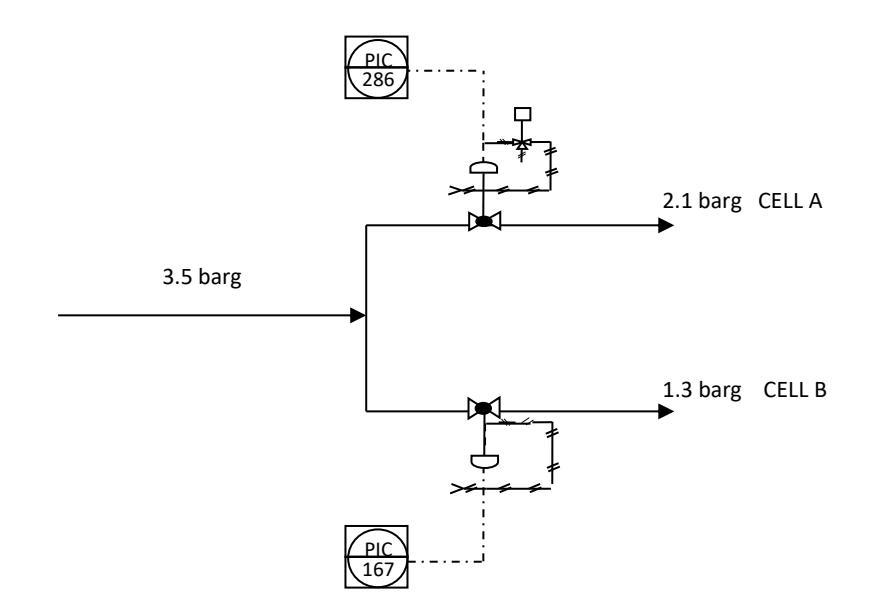
- 7.2. Despite the valves having very similar open positions, there was a discrepancy between the downstream pressures of each valve. The different fuel supply pressures under isothermal conditions would mean that different amounts of fuel flow rates are being provided to each cell. It was calculated that the cell with the lower pressure would actually have a greater fuel flow than the higher pressure cell since the fuel will have a reduced path of resistance via the low pressure route (note: as the valves have essentially the same %open position, the pressure drop across each can be assumed to be equal).

7.3. Considering that the valves are in the same position, equal pressure losses would apply to each valve and the incoming flow has the same flow area across the valve in either branch. Thus, the valves are not consequential in the analysis and the incoming flow of gas is more likely to flow down the greater pressure gradient in an attempt to equalise the pressure.

- 8.5.4. Maintenance check on PCV 286 and PCV 167: To ensure correct operational performance
- 8.5.5. **Examine Coded Calculations for PIC control loops:** In order to ensure that the correct pressure is being supplied for a given heat requirement. All measuring device elements and transmitters should be also be checked.

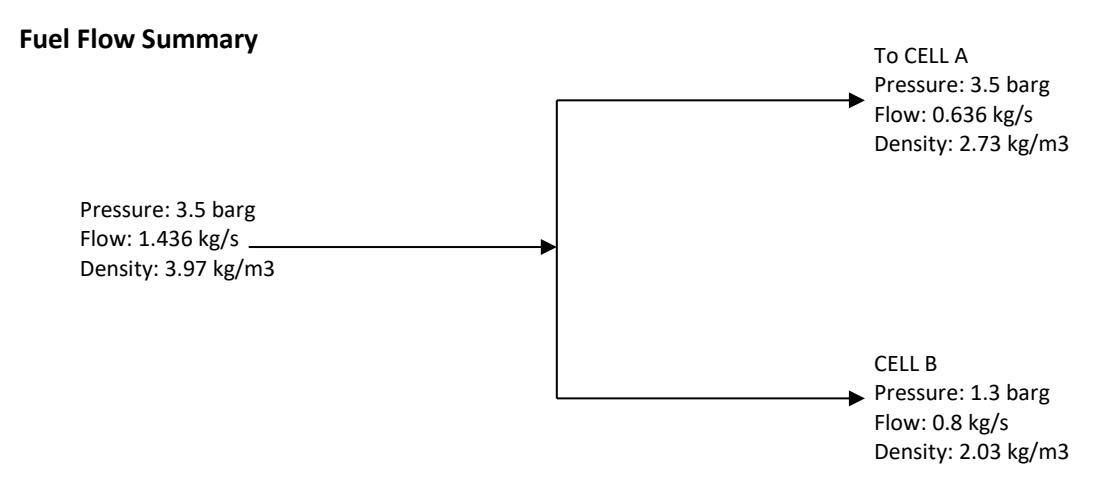
- 7.14. Minimum Air Fuel Ratio (AFR) = 13.9 (for stoichiometric combustion)
- 7.15. Maximum Air Flow Rate into each cell @ design duty: 11.05 kg/s
- 7.16. Cell A AFR: 11.05 / 0.636 = 17.4 (above 13.9, thus Combustion conditions OK)
- 7.17. Cell B AFR: 11.05 / 0.8 = 13.8 (below 13.9, CO production will to occur in real operating scenario)

The above conclusion also explains why Cell B consistently has a lower measured O2 reading in comparison to Cell A.

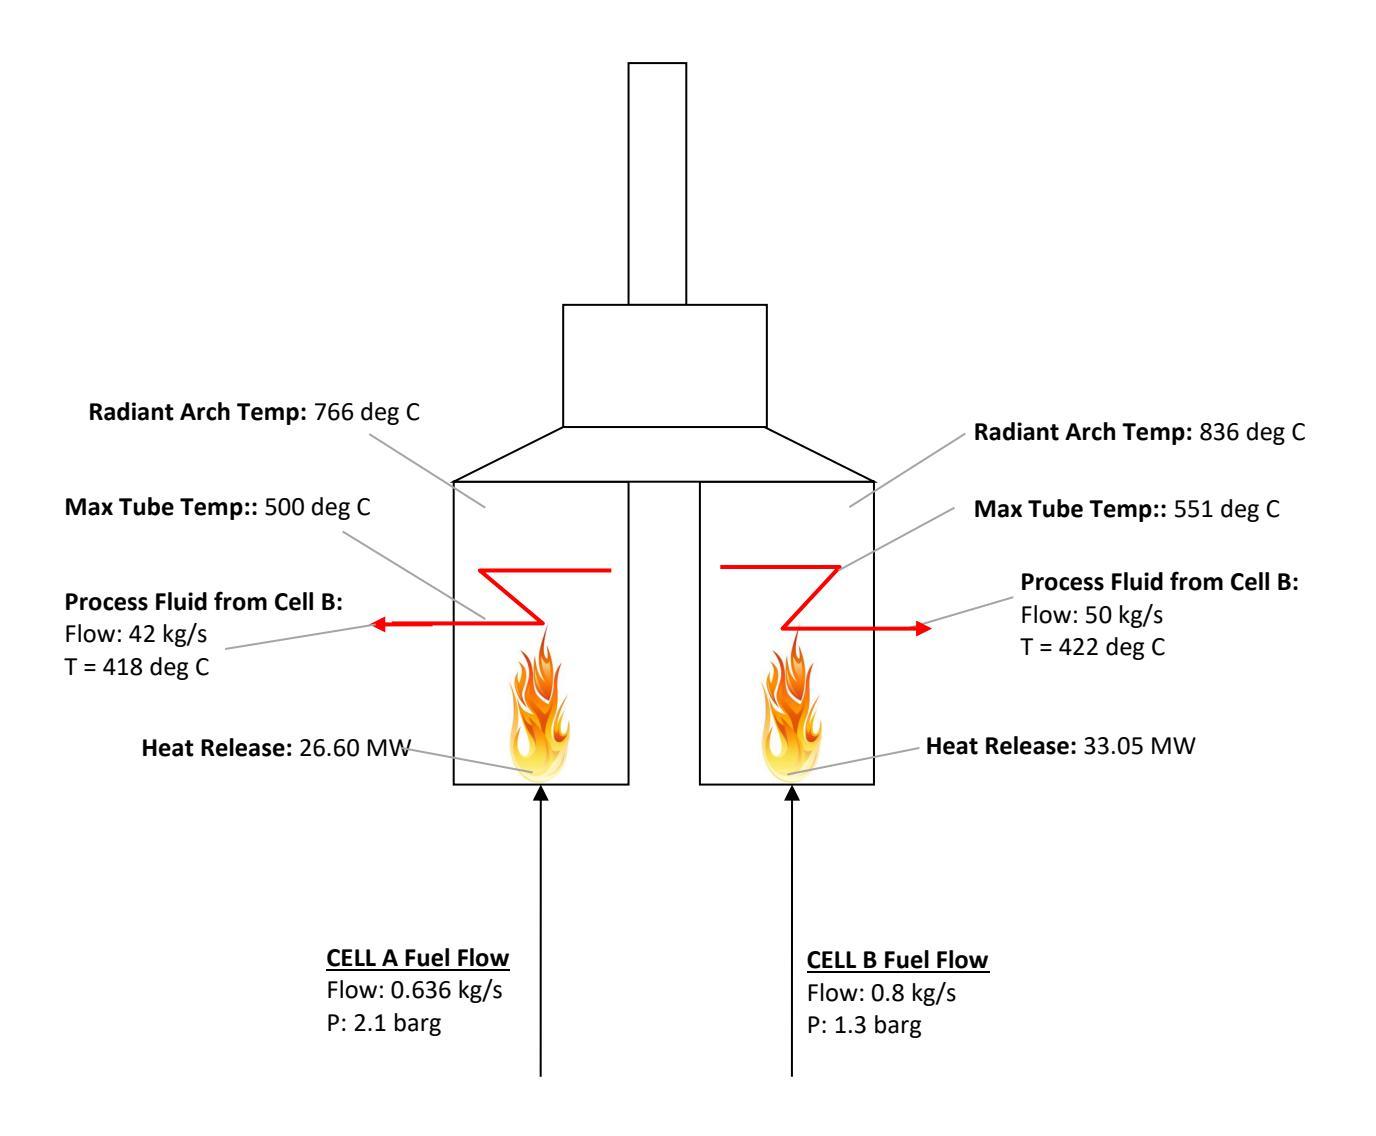
7.22. Summary Model of Current Furnace Operation:

ltem	Cell A	Cell B
Total Heat Absorbed, MW	16.25	19.27
Heat Release, MW	26.60	33.05
Process flow, kg/s	42	50
Temp. at arch, °C	766	836
Max Tube Temp. deg C	500	551
Avg. Radiant Flux W/m2	23,963	28,957
Combustion Air flow, kg/s	11.05	11.05
Fuel gas flow rate, kg/s	0.636	0.8
Excess Air, %	25	0

7.21. It is considered fortunate that cell B with a greater firing rate also has a greater mal-distributed process flow rate. The process fluid measured temperature discrepancy would be more severe if Cell B had the lower process flow rate and could potentially result in disturbance in downstream process units/equipment.
