Fired Heater Study Report

Vacuum Heater

HeaterSIM ref: H-13114

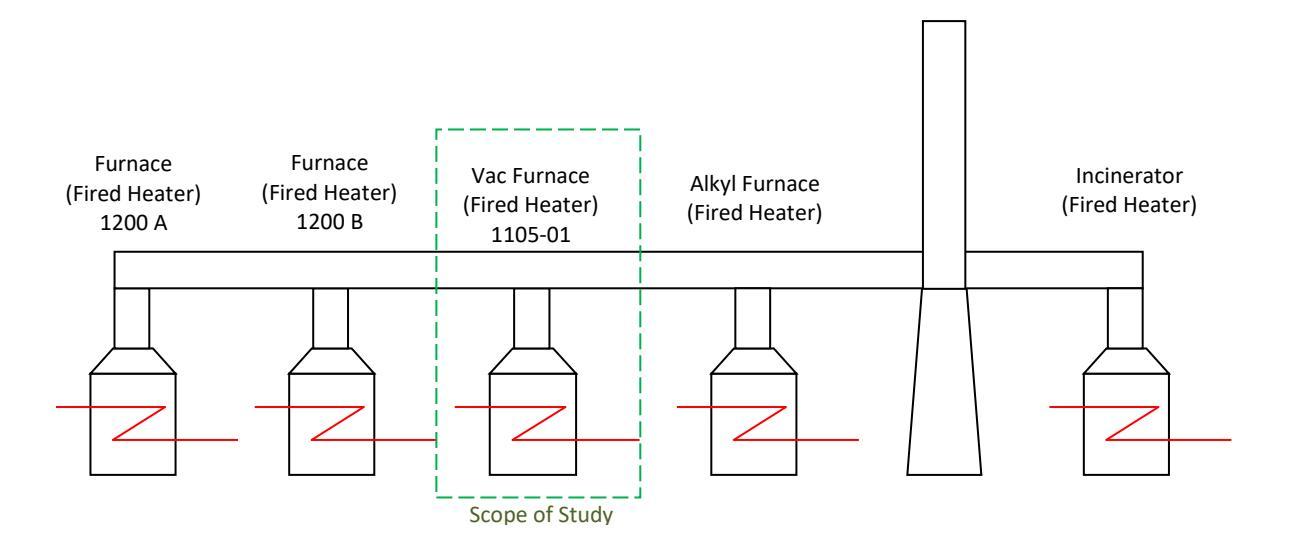
2.1. This report examines the Vacuum Heater 1105-01 at the CLIENT Refinery, which has a Twin Cell Cabin configuration with a common convection section and a shared ducting and stack system. There are a total of 20 natural draft burners (10 per cell) located in the floor.
